**Bainbridge Island Metropolitan Park & Recreation District  
Regular Board Meeting 6:00 pm  
Thursday – February 16, 2023**

| <b>40.4</b> | Stemper Report on Ray Williamson Pool<br><b>Action:</b> Information only. | Harry | (30 min) |

**RAY WILLIAMSON POOL  
COMPREHENSIVE CONDITION REPORT  
BAINBRIDGE INSLAND METRO PARK & RECREATION DISTRICT  
PROJECT NO.: 2208 FINAL DRAFT**

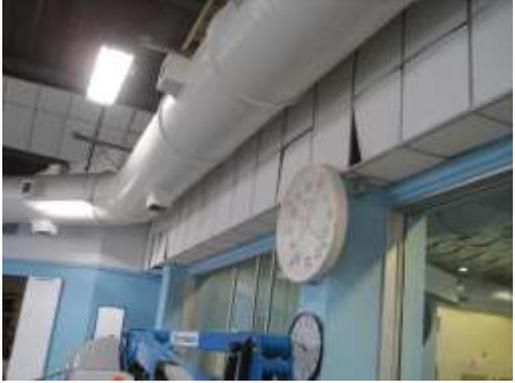
<b>Description</b>	<b>Photo</b>
<p>1. Acoustical ceiling tile</p> <p><i>Deficiency:</i> acoustical tiles on the north entrance are displaced and damaged in some areas</p> <p><i>Recommendation:</i> replace damaged tiles. If budget allows, consider installing a GWB soffit and provide access panels to mechanical unit as needed.</p>

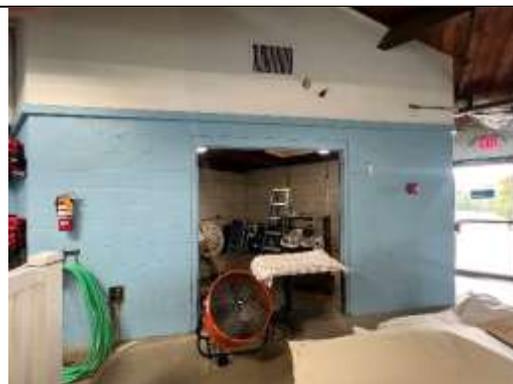
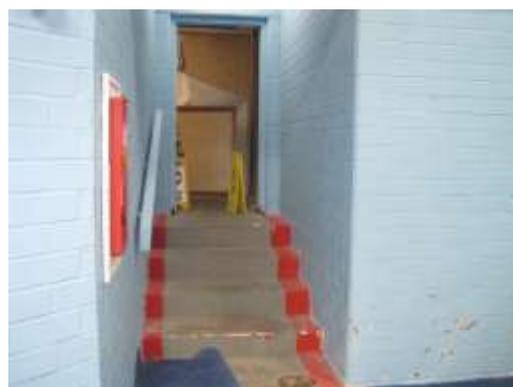
2. Natatorium – aged and worn paint

*Deficiency: paint peeling, damaged and wall discoloration is evident in various locations throughout the natatorium and auxiliary spaces.*

*Recommendation: patch, prepare and repaint walls with epoxy coating.*

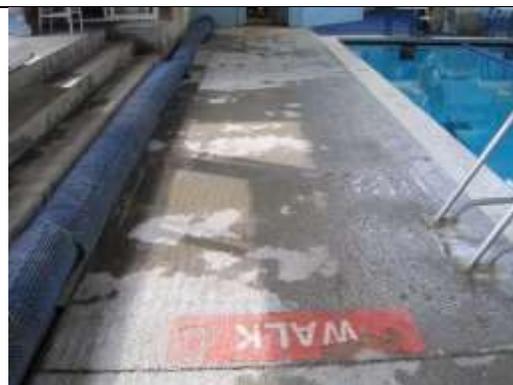
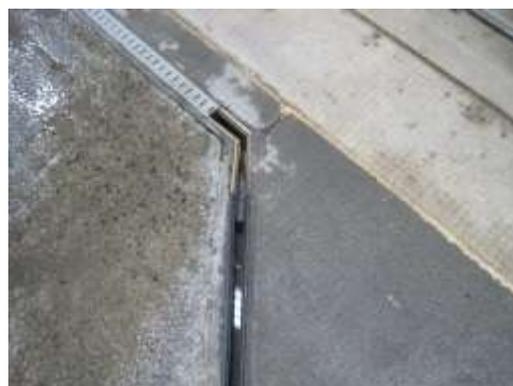
3. Pool Deck and drains

*Deficiency: constant use of the pool and deck maintenance over time has caused the concrete surfacing to erode – pitting and exposed aggregate is typically seen on the entire pool deck surface. The rubber mat overlay pattern has also imprinted into the concrete deck as part of the erosion over time. There are visible hairline cracks in multiple locations along the deck, particularly at linear drain locations. Deck drains are also aged and have missing linear drain covers in various locations, and the concrete adjacent to the drains are eroding. Refer to structural report for additional observations.*

*Recommendation: if pool deck is to remain in place, repair and seal existing cracks at the pool deck; Consider a urethane coating system over the pool deck; revise and repair deck drainage system where damaged or covers are missing, or consider replacing the linear drain system with a new linear deck drain. Coordinate with structural report for similar items.*

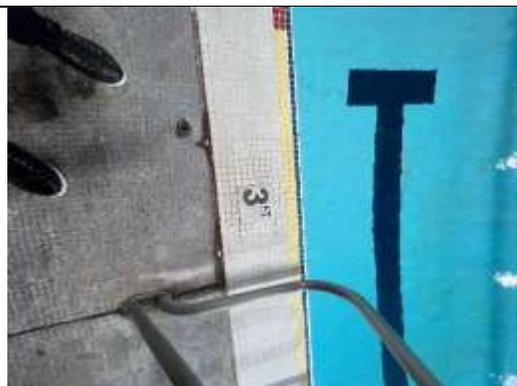
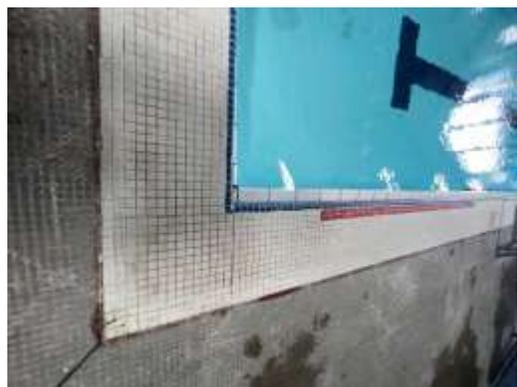
4. Perimeter tile at pool side

Deficiency: The tile and grout is aged, depth markers are worn and limited in legibility, and there are no diving signs at the pool perimeter area; replace perimeter tile to match Nakata pool. Construction joint material between tile and concrete is aged.

Recommendation: replace the perimeter tile and tile depth markers at the pool. Replace construction joint at tile perimeter. [note: this may trigger a need for replacement of the existing cantilevered gutter; coordinate with structural]

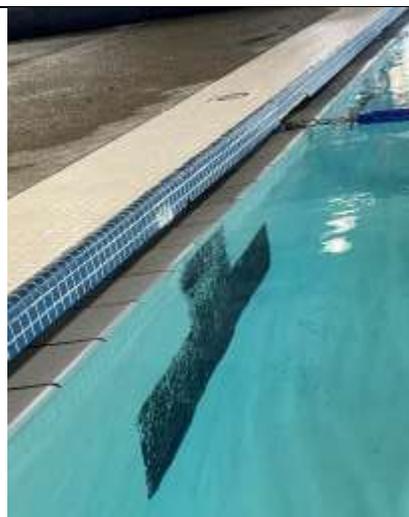
5. Pool lane markers and dividers

Deficiency: the existing lane markers in the pool tank are worn and fading. The line dividers are attached inside the pool gutter – challenging to install.

Recommendation: paint lane markers; owner requested to install lane divider anchors on the pool wall.

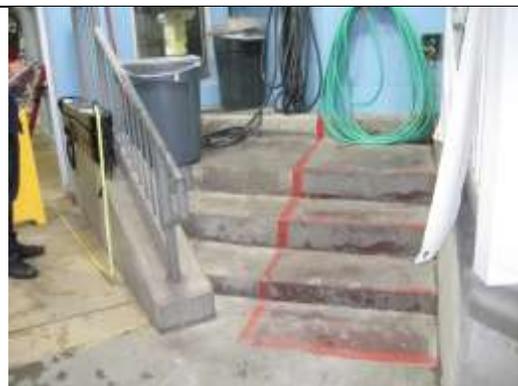
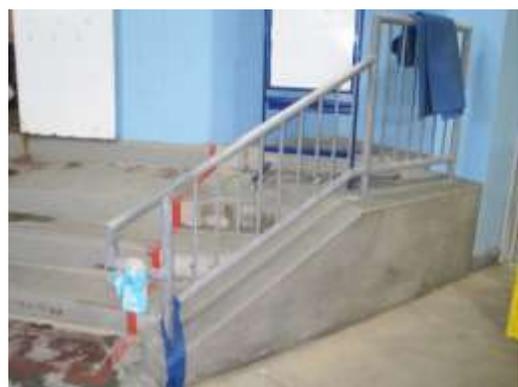
6. Paint at steps

*Deficiency: existing red paint is faded.*

*Owner also requested to paint boundary lines on pool deck for crowd control.*

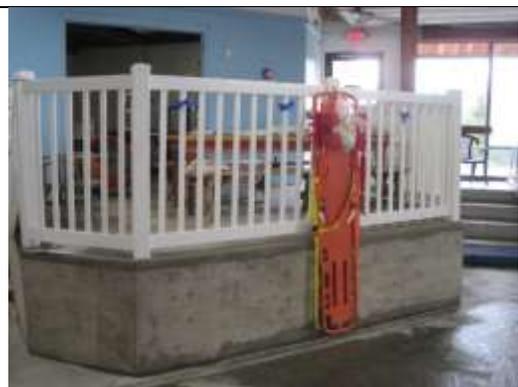
7. White PVC railing at concrete platform

*Deficiency: white PVC railing on the northeast platform is not anchored to the base and is freestanding. This is a safety issue and potential hazard.*

*Recommendation: permanently anchor PVC railing to concrete platform.*

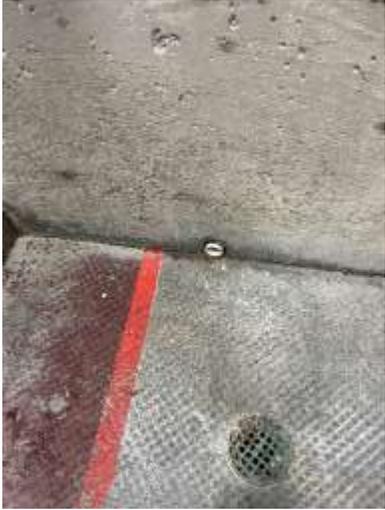
<p>8. Platform drain at northeast end</p> <p><i>Deficiency:</i> active drain is leaking under the concrete platform on the northeast end of the pool deck.</p> <p><i>Recommendation:</i> determine origin of leak and repair; coordinate with mechanical for drain line recommendations;</p>

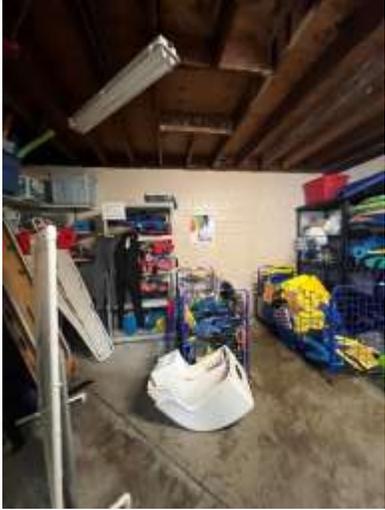
<p>9. Northwest storage room</p> <p><i>Deficiency:</i> water intrusion evident on storage room ceiling deck and joists.</p> <p><i>Recommendation:</i> investigate origin of water leak source and repair area to prevent additional leakage (potentially from existing aged roof); replace any wood rotted boards or members.</p>

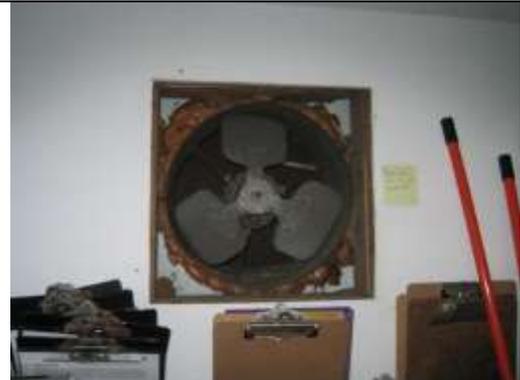
-12. Southeast natatorium office

Deficiency: existing fan in office is missing cover. Is this still functioning?

Recommendation: add fan cover or replace fan with new assembly. Determine if this fan is still necessary. If not, remove the fan and patch/repair/paint opening.

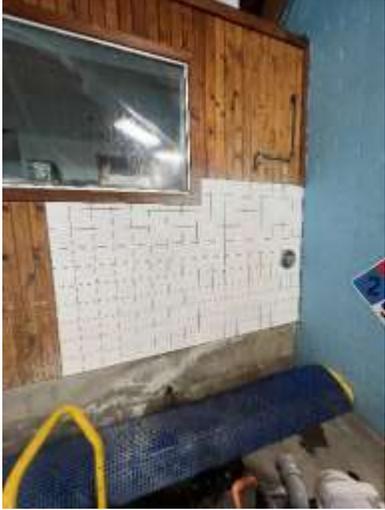
<p>13. Southeast natatorium office</p> <p><i>Deficiency:</i> existing drain and shower head at exterior wall of office appears to be active and showing water staining on concrete pony wall.</p> <p><i>Recommendation:</i> if active, coordinate with mechanical to determine a more efficient location. If not active, remove shower head, handle and tile, patch and finish wall to match adjacent wood and finish.</p>

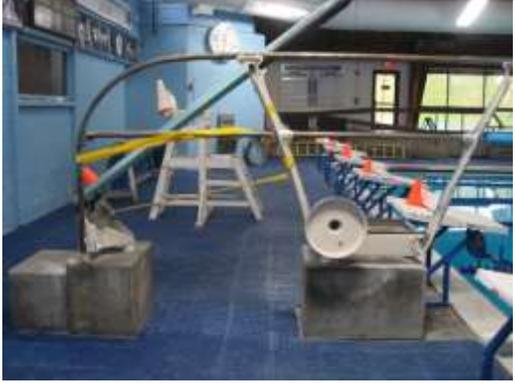
<p>14. Existing diving board</p> <p><i>Deficiency:</i> handrail/guardrail on diving board is corroded.</p> <p><i>Recommendation:</i> replace hand rail.</p> <p>Owner requested to move existing diving board; relocation of diving board is to comply with FINA and structural support requirements.</p>

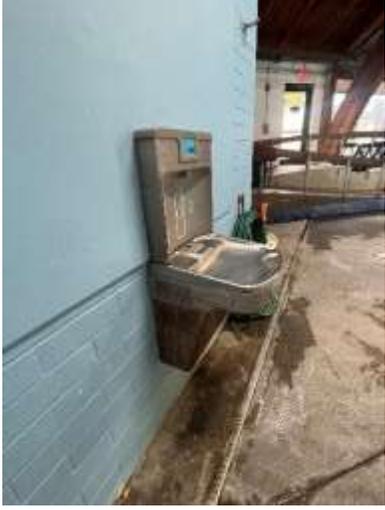
<p>15. Existing drinking fountain – southwest end</p> <p><i>Deficiency:</i> existing drinking fountain is aged and corroded.</p> <p><i>Recommendation:</i> remove drinking fountain replace with new fixture. Refer to mechanical report for this item.</p>

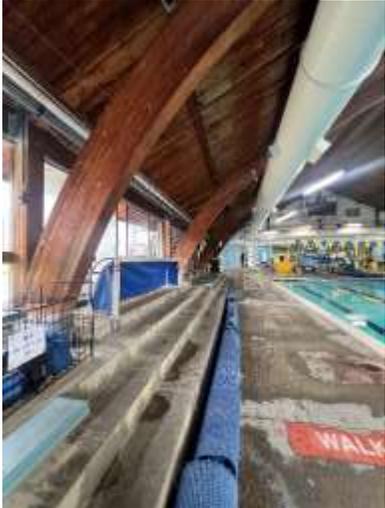
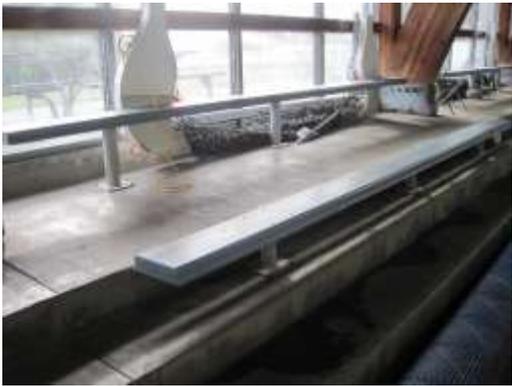
<p>18. Pool deck steps on east and west sides <i>Deficiency:</i> bench steps are not ADA compliant and do not provide an accessible spectator area. <i>Recommendation:</i> Owner request to remove existing steps and install aluminum benches/ bleachers (3-4 tiers). This may trigger overall deck replacement and a substantial alteration designation for permitting; this item to be coordinated with structural and Owner.</p>

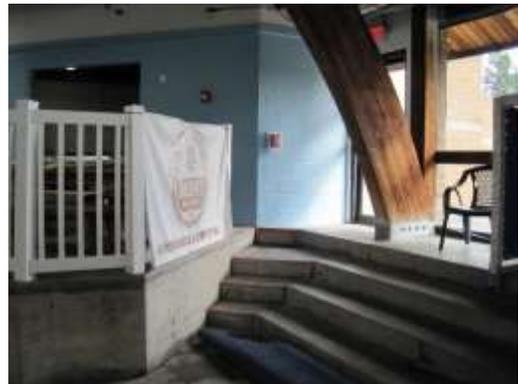
20. Public storage room at northwest and northeast  
*Deficiency: Public storage is not ADA accessible. Ceiling is in poor shape – moisture intrusion visible.*  
*Recommendation: replace damaged wood members. Make this a staff use/storage area only.*

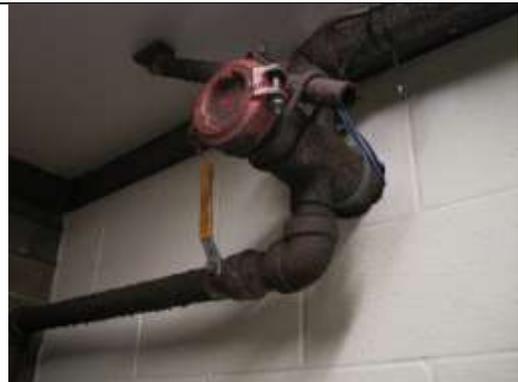
21. Natatorium/ Locker rooms/ storage rooms sprinkler heads and other plumbing pipes  
*Deficiency: existing sprinkler and plumbing pipes are extremely corroded.*  
*Recommendation: clean all corroded pipes and coat with anti-corrosive coating. Refer to mechanical for this item.*

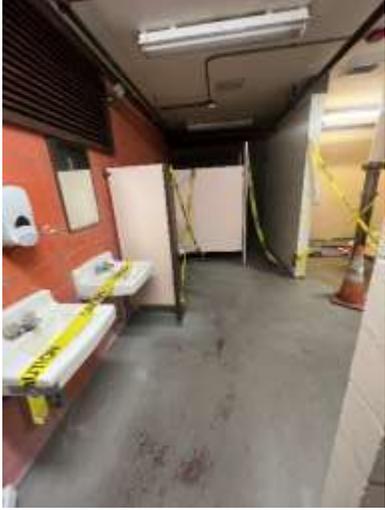
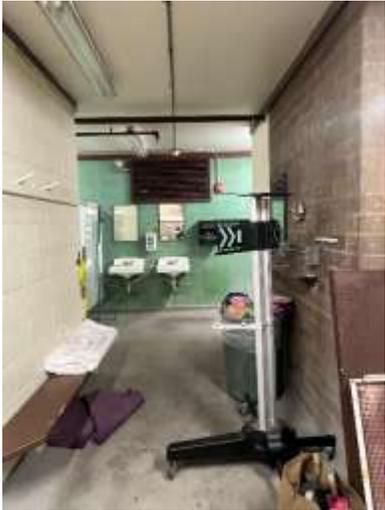
<p>22. locker rooms</p> <p><i>Deficiency:</i> men's and women's locker rooms are non-functioning.</p> <p><i>Recommendation:</i> Women's Locker room: repurpose/recondition locker rooms to be staff storage, enlarge existing office space, and add a staff restroom; Owner requested that Men's Locker Room: be repurposed to be location for new sand filter system.</p>

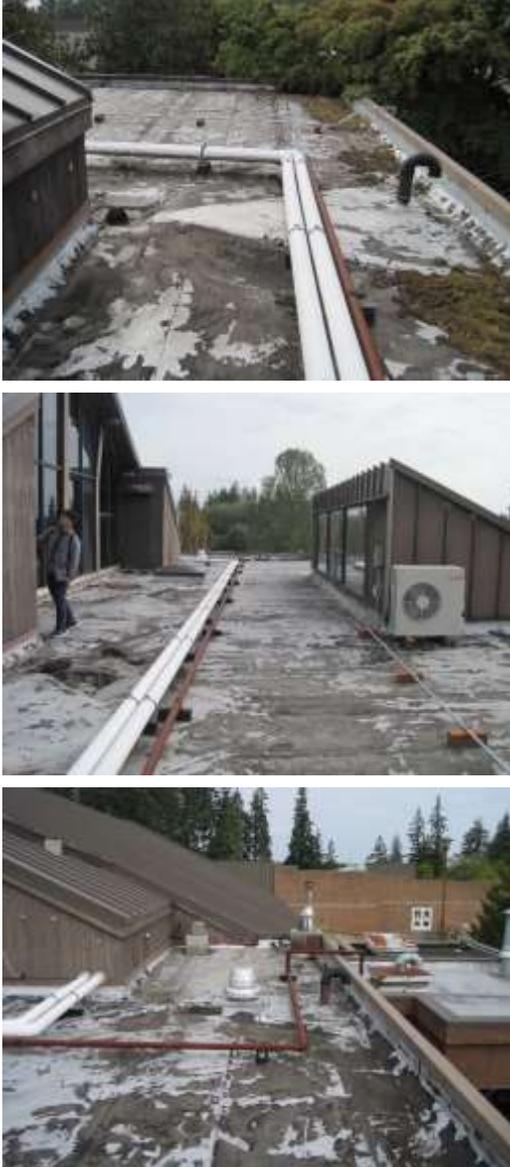
<b>Description</b>	<b>Photo</b>
<p>29. Low slope membrane roof</p> <p><i>Deficiency: existing low-slope membrane roof is severely aged with apparent heavy wear and tear. Ponding occurs in several areas, and may have moisture intrusion in the insulation layers underneath (an infrared test and destructive testing were not performed); protective coating over sheet membranes is disintegrated and completely failed. (was the previous sheet membrane repaired prior to applying the coating?)</i></p> <p><i>Recommendation: replace low-slope membrane roof in its entirety. Include a fall protection system as part of the scope of work.</i></p>

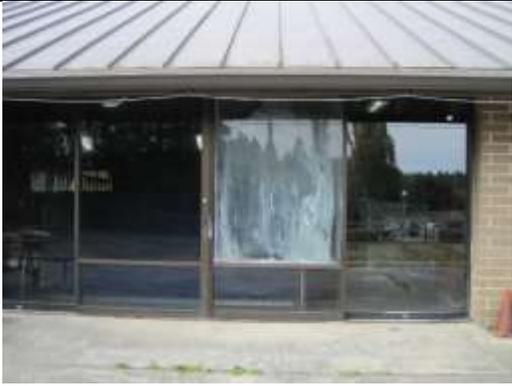
<p>36. Exterior sliding doors – east and west <i>Deficiency:</i> exterior sliding doors are aged and failing – seals are compromised and condensation and calcification have occurred at interior air space between the glass. <i>Recommendation:</i> Replace sliding glass doors – existing system is Kawneer; StemperAC is reviewing available compatible replacement sliding glass doors.</p>

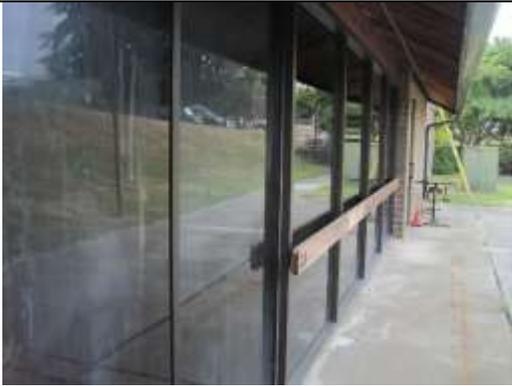
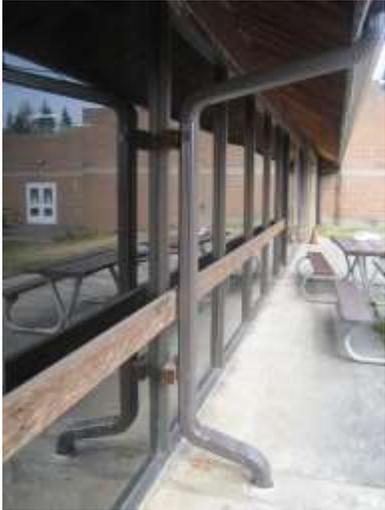
<p>37. Storefront windows – east and west</p> <p><i>Deficiency:</i> existing windows are aged, seals are failing, and some frames are corroded.</p> <p><i>Recommendation:</i> Replace storefront window system in its entirety; as with the sliding glass doors which are part of the same storefront system, StemperAC is reviewing options for a compatible system to replace this one.</p>

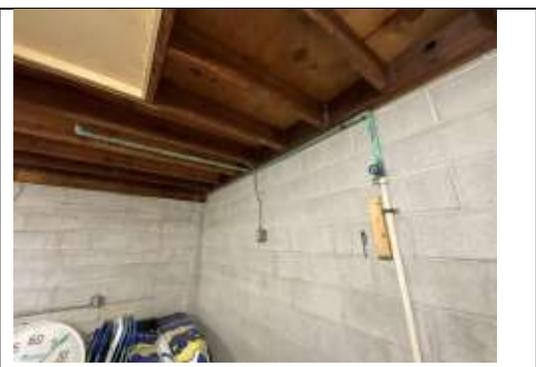
<p>5. Domestic Water Piping (Secondary - wear and tear) <i>Deficiency: M005</i> <i>Recommendation:</i> Chlorine fumes have deteriorated the domestic water piping. Replace all domestic water piping with plastic pipe.</p>

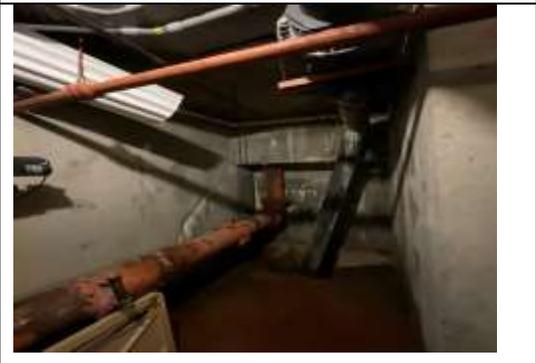
<p>6. Pool drainage piping (Secondary -Wear and tear) <i>Deficiency: M006</i> <i>Recommendation:</i> The pool drain piping is the original steel materials and is suspected of leaking. Line all existing pool drain piping with a plastic liner system.</p>

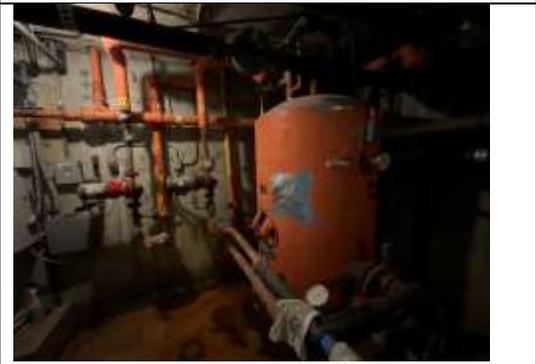
<p>7. Domestic water heater (Secondary -wear and tear) <i>Deficiency: M007</i> <i>Recommendation:</i> The domestic water system has failed and is abandoned in place. Install a new domestic Point of use water heaters with new area re-configuration.</p>

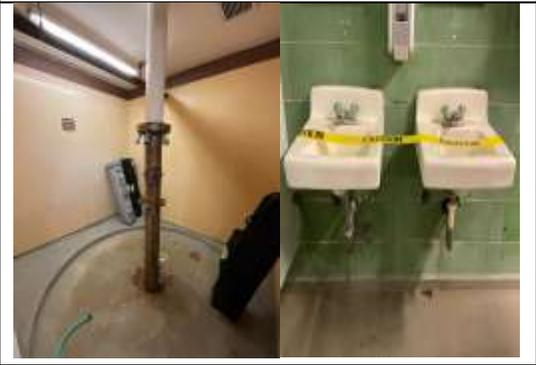
<p>8. Plumbing fixtures (Secondary -Wear and tear) <i>Deficiency: M008</i> <i>Recommendation:</i> Demolish all plumbing fixtures and install new fixtures required for reconfiguration of space.</p>

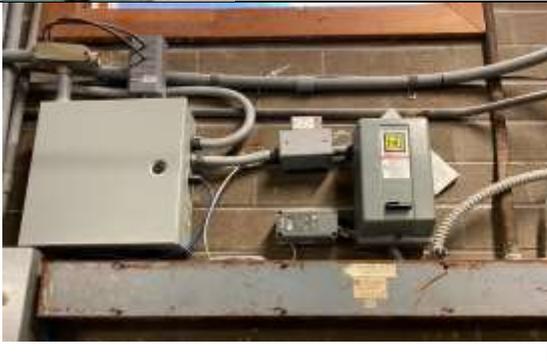
<p>4. Miscellaneous electrical raceways, auxiliary gutters, boxes, fittings, supports (Secondary – wear &amp; tear) <i>Deficiency:</i> These items are in various states of corrosion. <i>Recommendation:</i> Replace with materials suitable for wet/natatorium locations.</p>
