**Bainbridge Island Metropolitan Park & Recreation District  
Regular Board Meeting 6:00 pm  
Thursday – February 16, 2023**

| <b>40.4</b> | Stemper Report on Ray Williamson Pool<br><b>Action:</b> Information only. | Harry | (30 min) |

**RAY WILLIAMSON POOL  
COMPREHENSIVE CONDITION REPORT  
BAINBRIDGE INSLAND METRO PARK & RECREATION DISTRICT  
PROJECT NO.: 2208 FINAL DRAFT**

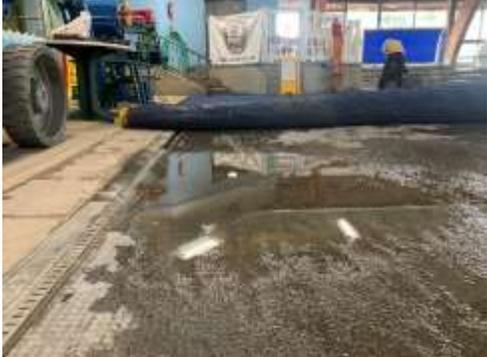
<b>Description</b>	<b>Photo</b>
<p>1. Inadequate slope of pool deck and management of deck mats  <u>Deficiency:</u> <i>Insufficient slope to trench drains</i>  <u>Recommendation:</u> <i>Excavate concrete and replace trench drains at areas where ponding is occurring.</i></p>

1. Inadequate slope of pool deck and management of deck mats

The pool deck is covered by walking mats, which reduce the risk of guests slipping compared with untreated bare concrete. Beneath the mats there is evidence that the concrete surface is not sloped adequately to avoid small amount of water to pond rather than flow to the floor drains as intended. To avoid health issues and maintain a clean and sanitary pool deck, the maintenance staff rolls up the mats each evening and cleans the floor. This routine tedious task can be eliminated by removing defective and unbonded concrete deck and provide an overlay sloped adequate for water to flow toward the trench drains and with surface roughness adequate to mitigate the slipping hazard.

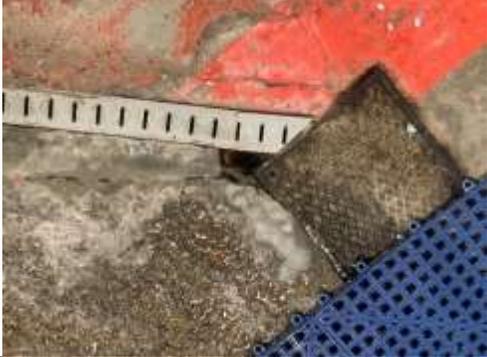
<p>2. Scaled and cracked concrete at pool deck  <u>Deficiency:</u> <i>Concrete deterioration, some local delamination and small cracks in a few places.</i>  <u>Recommendation:</u> <i>Remove deteriorated surfaces, prepare surface, and provide polymer modified overlay. Pressure-inject cracks.</i></p>

2. Scaled and cracked concrete at pool deck (Figure 2)

Scaling of concrete surfaces, delamination, and cracks will allow chlorine water to penetrate the concrete, corrosion to occur in the rebar, and water to seep into the ground beneath the concrete deck. Repairing these defects will extend the life of the structure and reduce future maintenance costs.

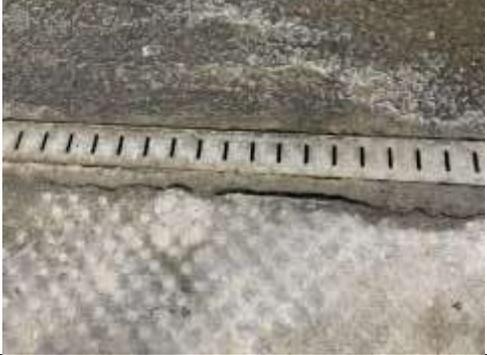
<p>3. Deterioration at trench drain <u>The linear trench drain extends around the entire pool. The drain is reportedly working as intended.</u>  <u>Deficiency:</u> <i>Cracked grout edging and missing components at trench drain</i>  <u>Recommendation:</u> <i>Remove deteriorated surfaces, and, prepare surfaces. Provide new edging grout where loose. Install new portions of trench drains were missing.</i></p>

3. Deterioration at trench drain

The FRP perimeter trench drain appears to have become brittle, with pieces broken or missing from the drain and grout around the drain failing. To improve the effectiveness of the drain in removing water from the concrete deck and reducing a safety hazard from broken FRP at the walking surface, the concrete can be cut on each side of the drain, the drain removed and replaced, and new non-shrink moisture resistant grout place continuously around the new drain.

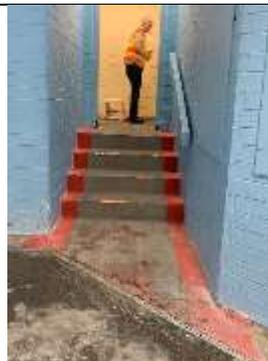
*Deficiency: Concrete deterioration apparently due to chlorine exposure*

4. Corrosion and scaling at south end steps

A local area of deteriorated concrete and corroded rebar exists at the south end of the pool where steps lead to an un-used locker room. Water seepage into the concrete has caused some local corrosion of rebar and spalling of the concrete surface. The repair needs to include removal of all disbanded and cracked concrete, replaced with a water-resistant concrete that has corrosion inhibitor and galvanic anodes where excavation is deeper than approximately 2 inches.

*Recommendation: Excavate deteriorated concrete, prepare surface, and provide overlay polymer modified overlay*

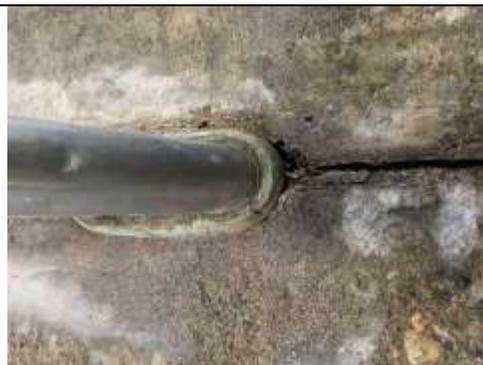
*Deficiency: Concrete deterioration apparently due to chlorine exposure*

5. Deterioration at post base at railing

The post base that supports a handrail near the southeast portion of the pool has concrete failing along a control joint in the concrete deck slab. The base material at the post is also deteriorated. The entire railing and base will likely need to be removed and refurbished or replaced. The concrete at the base needs to be excavated, a new post base connection provided, and the concrete locally patched in this area. This repair can be done in conjunction with deck overlay work or done as a stand-alone repair, depending on the extent of the mitigation work selected.

*Recommendation: Excavate concrete to sound material, replace railing and post base, and patch concrete locally at repair area.*

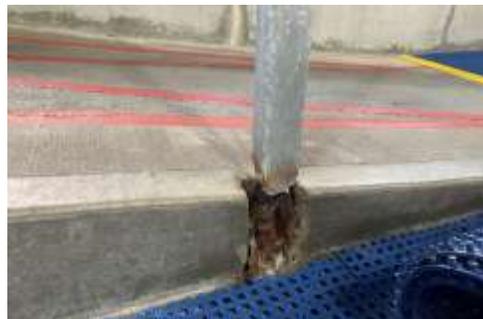
6. Steel post at ramp guardrail

*Deficiency: Corrosion at galvanized steel post*

6. Corroded steel post at ramp guardrail

Significant corrosion has damaged the galvanized steel post that supports the guardrail along the southwest concrete ramp. The post and rail system needs to be removed and replaced with stainless steel for a more durable and lasting solution than the current galvanized steel. The concrete needs to be excavated to expose the connection and deteriorated concrete, the new rail and post reconnected, and the concrete patched.

*Recommendation: Removed the post from the rail, excavate the damaged concrete and connection. Replace the post and reconnect to the concrete; then patch the concrete at the post base.*

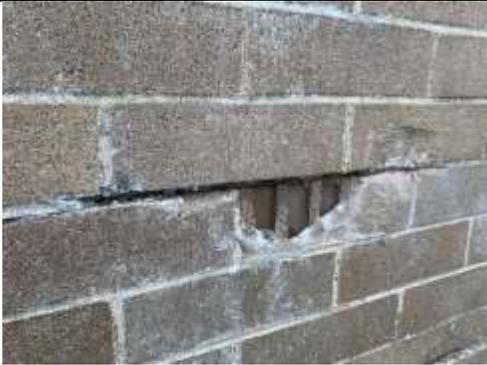
<p>7. Brick and mortar damage</p> <p><u>Deficiency:</u> Broken bricks, missing faceshells, and deteriorated mortar throughout. Not all damage could be observed, although efflorescence staining from moisture intrusion is seen at many locations along with evidence of previous repairs of mortar and reinforcing.</p> <p><u>Recommendation:</u> Remove damaged brick and K-web reinforcing where corroded and replace. Remove mortar throughout the building envelope, repoint, clean and seal all brick to protect against further moisture intrusion.</p>

7. Brick and mortar damage

The majority of the building envelope where glazing does not occur is formed with brick over CMU block. Due to the age of the mortar, the extensive wear and deterioration, and the exposure of moisture to the reinforcing K-web bars, the brick mortar needs to be removed, reinforcing exposed and replaced where corroded, and the mortar replaced on the exterior. Cleaning and sealing of all brick is required to provide durability and protection against future moisture intrusion. Broken and damage brick needs to be removed and replace at local areas.

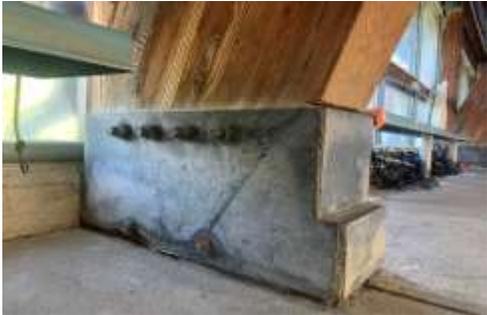
<p>8. Corrosion at glu-lam base connections</p> <p><u>Deficiency:</u> Galvanized GL beam bases have spots of corrosion at some locations.</p> <p><u>Recommendation:</u> Removed corrosion from bolts, nuts and plates or replace as required.</p>

9. Corrosion at glu-lam base connections

There is a small amount of corrosion and concrete deterioration at a galvanized base for the curved glu-lam based attachment to the concrete deck. As part of the refurbishment and for the purpose of extending the life of the structure, the concrete needs to be removed where signs of spalling and delaminated concrete exist. The corrosion in the steel base can be removed by grinding and re-coated with a galvanized paint and potentially epoxy coating as determined suitable by the Owner and Architect. Any bolts with evidence of corrosion need to be replaced in kind or with stainless steel bolts separated from the galvanized steel with nylon washers.

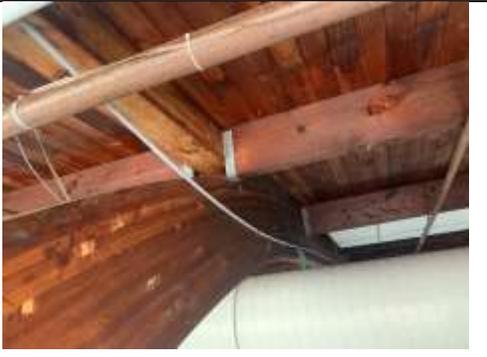
<p>9. Glu-lam beam and wood decking roof faming</p> <p><u>Findings:</u> <u>Glulam wood arch beams and timber T&amp;G decking support the semi-arched clear-span over the natatorium.</u> Where the framing was observed up close and soundings made, the glulam beams were found to be in good condition with no signs of deterioration or structural cracking at the laminations.</p> <p><u>Recommendations:</u> No work required. Improved ventilation will help reduce risk of future damage.</p>

No significant repair work is currently required at the roof.

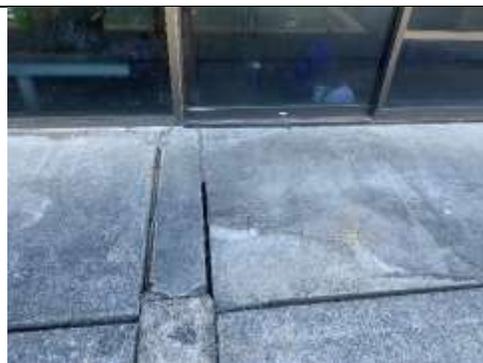
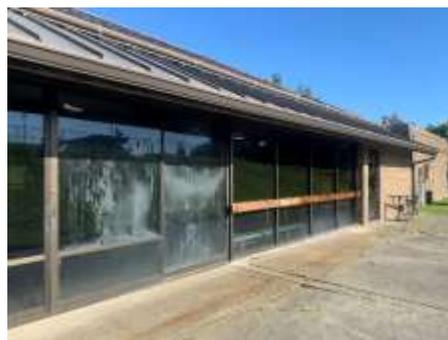
10. Exterior concrete walkways

*Deficiency: Concrete is cracked, settled, and joint material missing.*

10. Repair at exterior concrete walkways (Figure 3)

Numerous portions of the concrete slab-on-grade are cracked, heaved, and causing a tripping hazard. Repair of these areas can be made by removing the concrete and a portion of subgrade, then replacing the soil with granular fill and replacing the concrete using control joints to match existing

*Recommendation: Remove deteriorated concrete and approximately four inches of soil, provide granular fill and replace concrete and joints.*

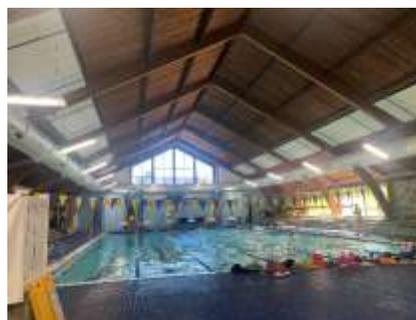
*Deficiency: Pool at north end is too shallow for swimmer's turn*

11. Inadequate depth of pool at shallow end (Figure 4)

The shallow end of the pool is approximately three feet deep, inadequate for competition swimming wear a swimmer's turn is required. The challenge with deepening the pool is bracing and underpinning the existing wall during construction. The wall as designed may not have adequate reinforcing and strength to resist the lateral soil induced loads. Bracing would be required, and a thicker wall and larger footing designed to resist great loads from the taller retaining wall. To provide a smooth transition between the deeper end at the south side of the pool and the retrofit at the north side, the construction would likely start at mid-pool length. Excavation of soil, a new compacted sub-base, and re-casting of the reinforced concrete pool bottom

would be required. Coatings on the concrete and replacement of existing features would be provided as required.

*Recommendation: Shore the concrete walls and underpin. Excavate concrete from pool mid-length and remove concrete and soil as required to reach desired depth of approximately five feet. Compact soil and place new concrete and with water barriers, waterstops and aquatic concrete mix. Finish to match existing.*

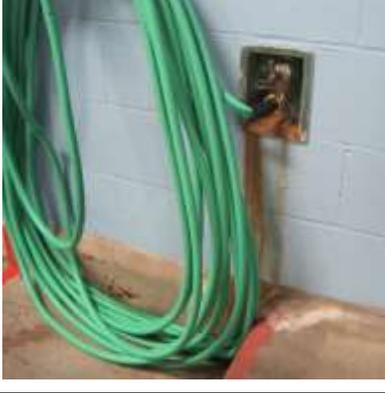
<p>10. Hose bib on northeast wall</p> <p><i>Deficiency:</i> the existing hose bib on the northeast wall of the storage room is corroded. Rust drips have appeared over time.</p> <p><i>Recommendation:</i> repair leak at hose pipe (could be a gasket replacement); replace corroded hose bib housing assembly, and seal the flanges at face of cmu wall.</p>

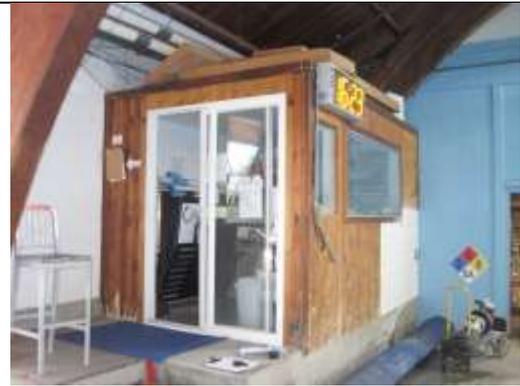
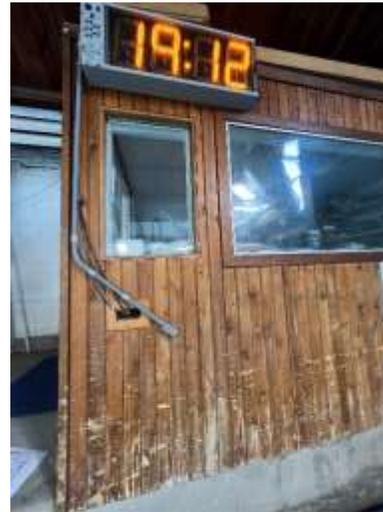
11. Southeast natatorium office

Deficiency: wood panel boards on office at southeast end of pool is aged and damaged near the base.

Recommendation: sand/repair, stain and seal wood to match original condition; replace damaged or rotted boards.

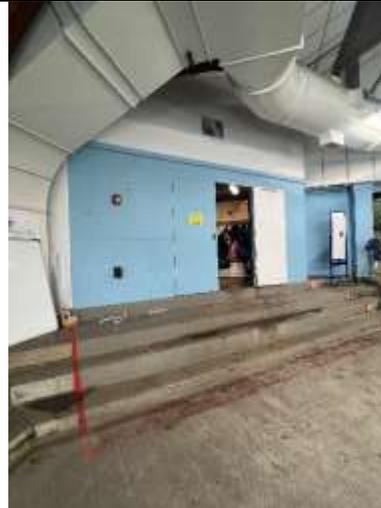
20. Public storage room at northwest and northeast  
*Deficiency: Public storage is not ADA accessible. Ceiling is in poor shape – moisture intrusion visible.*  
*Recommendation: replace damaged wood members. Make this a staff use/storage area only.*

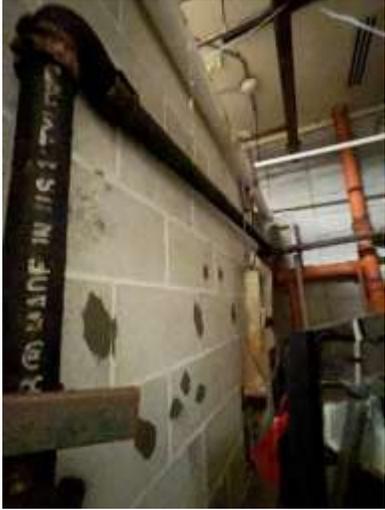
21. Natatorium/ Locker rooms/ storage rooms sprinkler heads and other plumbing pipes  
*Deficiency: existing sprinkler and plumbing pipes are extremely corroded.*  
*Recommendation: clean all corroded pipes and coat with anti-corrosive coating. Refer to mechanical for this item.*

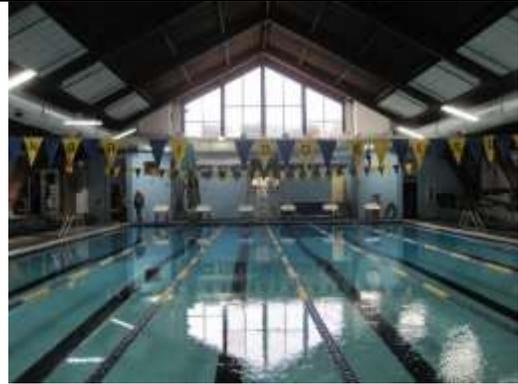
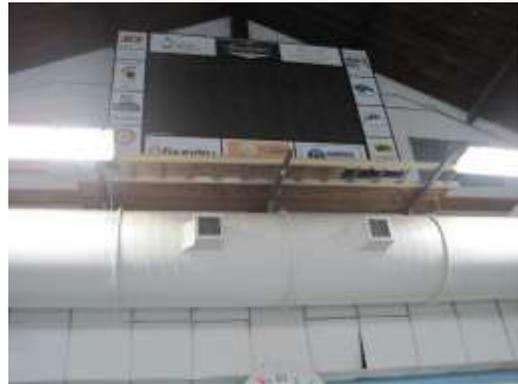
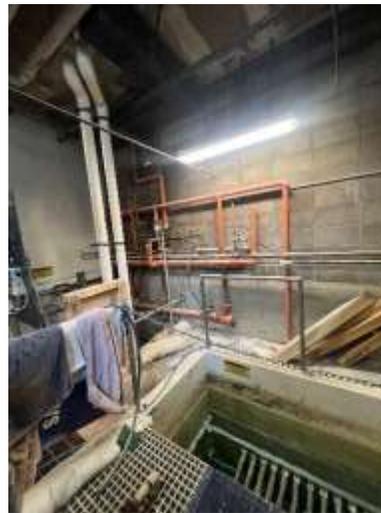
*Deficiency: existing fluorescent lighting is outdated and non-compliant with current WSEC.*

*Recommendation: replace the lighting with new code compliant energy conscious lighting; coordinate with electrical report.*

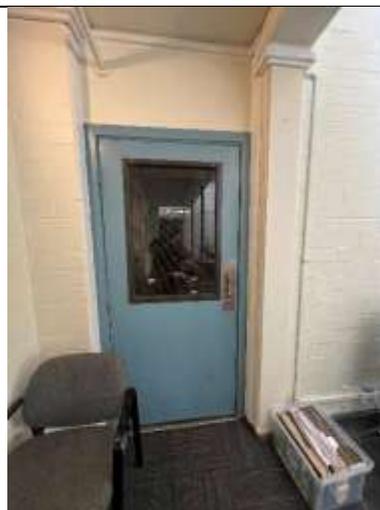
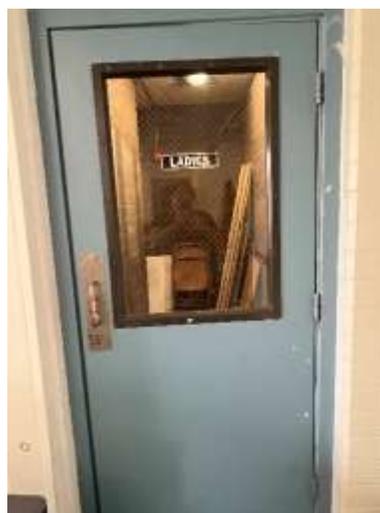
24. Office doors

*Deficiency:* Hardware on interior office doors is corroded, typical.

*Recommendation:* replace door hardware with similar and ADA compliant hardware.

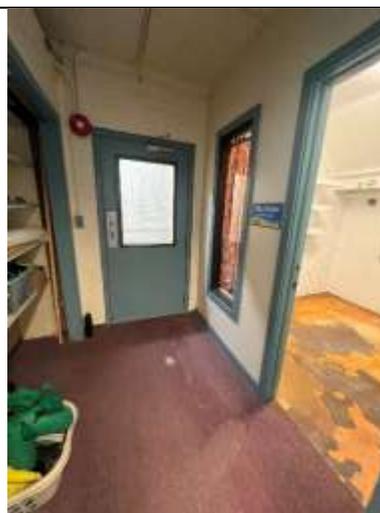
25. Office area

*Deficiency:* red carpet is aged with heavy wear and tear apparent.

*Recommendation:* replace red carpet with durable flooring for a pool environment.

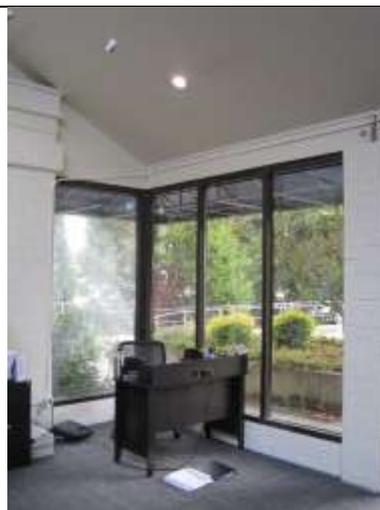
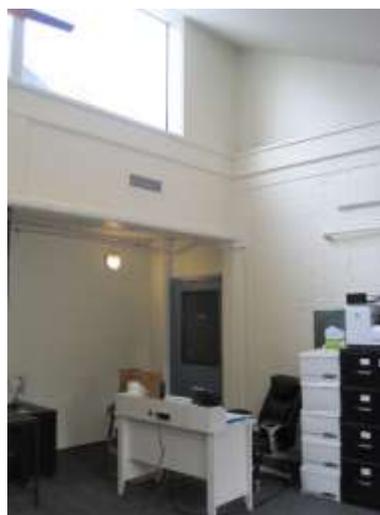
26. Entrance - desks

Deficiency: south entrance desks are in open area with minimal filing/storage space and no privacy.

Recommendation: add partitions for desk spaces and built-in casework for files/storage.

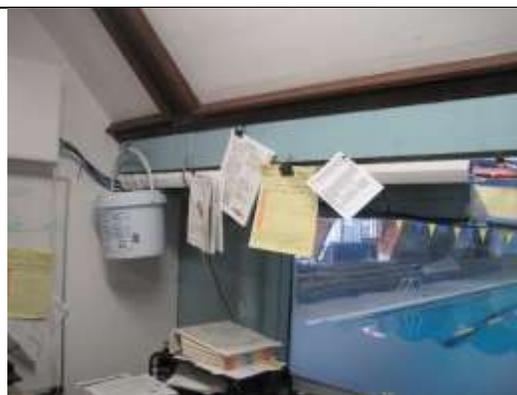
27. Staff Office – Mike Omans

Deficiency: Existing makeshift gutter at office due to a water leak, possibly from clerestory windows above that are telegraphing through the roof to the office below; gutter also is adjacent to existing active electrical wires and poses a hazard and life safety issue. The wiring/cable also extends out to the natatorium through a hole in the window.

Recommendation: Repair water leak and remove gutter. Coordinate cable relocation with electrical report.

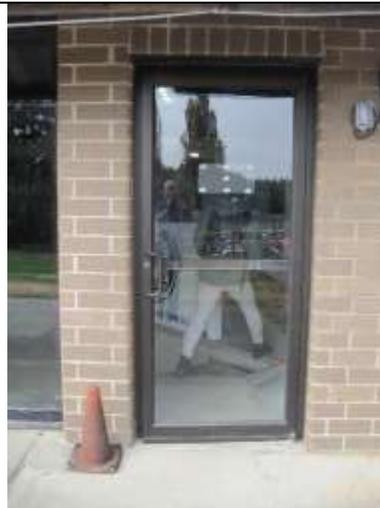
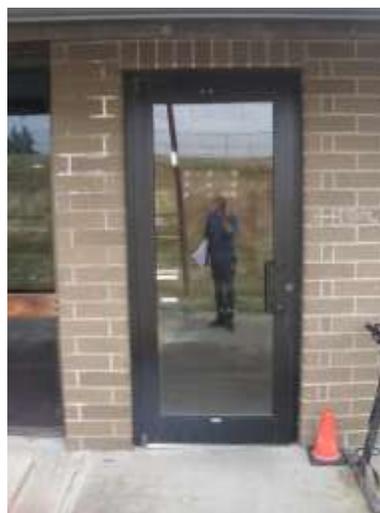
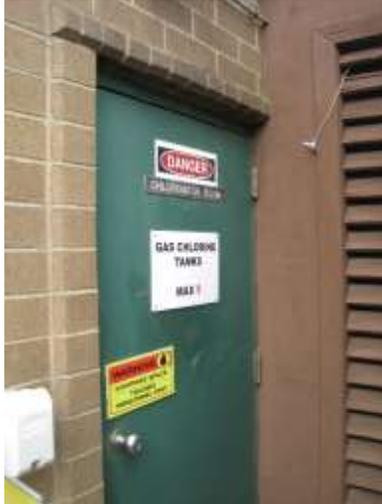
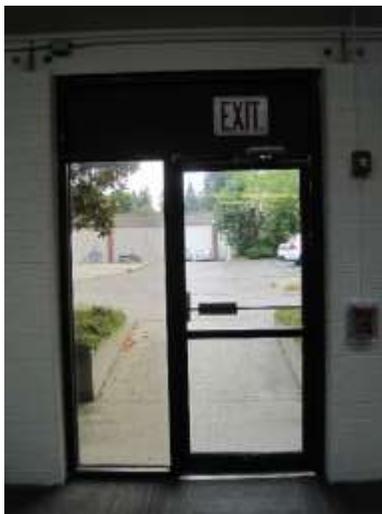
35. Exterior swinging doors – east, west and south

*Deficiency: exterior doors at natatorium and auxiliary spaces (such as chemical room and workshop space) are aged; hardware and frame are corroded, seals are failing.*

*Recommendation: Replace exterior doors and hardware.*

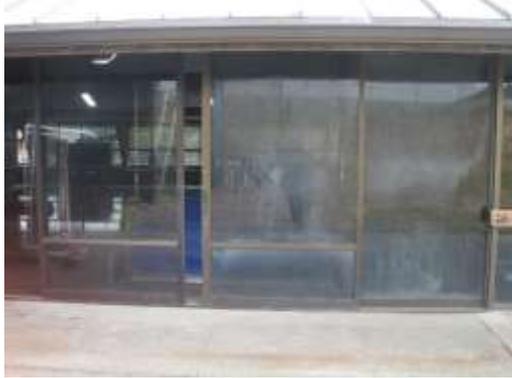
<p>36. Exterior sliding doors – east and west <i>Deficiency:</i> exterior sliding doors are aged and failing – seals are compromised and condensation and calcification have occurred at interior air space between the glass. <i>Recommendation:</i> Replace sliding glass doors – existing system is Kawneer; StemperAC is reviewing available compatible replacement sliding glass doors.</p>

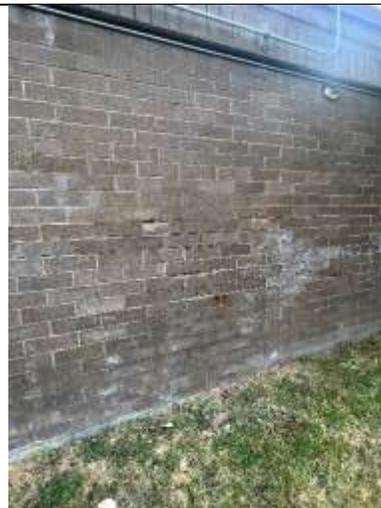
*Deficiency: existing brick is aged and efflorescing in various sections. Other sections are broken out*

*Recommendation: Repair, replace and repoint brick. Coordinate with structural assessment of brick.*

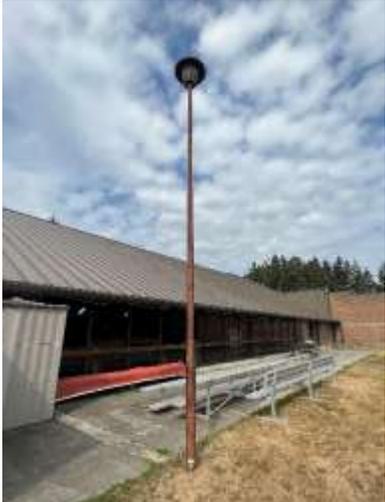
<p>43. East light pole</p> <p><i><u>Deficiency:</u> existing light pole is corroded</i></p> <p><i><u>Recommendation:</u> Remove and replace existing light pole and fixture.</i></p>

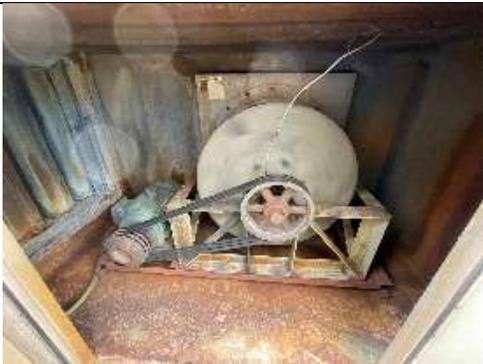
<b>Description</b>	<b>Photo</b>
<p>1. Pool area Heating/Ventilation system. (Critical - Life safety and energy code)  <u>Deficiency:</u> M001  <u>Recommendation:</u> Remove and replace existing, failing, ground mounted air-to-air heat exchanger unit.</p>

1. Pool HV system: The existing Heat Reclaim Heating/Ventilation unit was installed in 1998. The design does not comply with the current Washington State Energy Code. The existing HV Unit is badly deteriorated from exhaust side chlorinated air. Panels and access doors are badly rusted and control dampers are inoperable. The system requires replacement. A more complex, code compliant unit with dehumidification will need to be installed. The dehumidification system will require additional electrical power, which will necessarily require a building electrical service upgrade. The existing air-to-air heat exchanger uses 100% outside air with heat exchanger bypass dampers for mild temperature operation. Supply air is currently re-heated with a draw through hydronic coil, downstream of the heat exchanger. The hydronic loop serving the existing unit shall be re-used with the new dehumidification equipment. The distribution ductwork and aluminum diffusers within the pool room are in good shape and can be re-used. The existing exterior supply and exhaust ductwork is deteriorated and will require replacement and reconfiguration. The interior exhaust louver in the west wall of the pool enclosure is an aluminum sound attenuation louver. The louver is in good shape and can be re-used. The existing supply and exhaust fans are modulated by exterior ABB Variable Frequency Drives (VFD's), These VFD's are controlled by a Johnson Metasys DDC system but it is not known if the VFD's are fully functional. New fan motor modulation will be required. The old VFD's will be replaced by more modern ECM motor controls installed in the new equipment. The DDC system needs to be upgraded to accommodate the newer, more complex equipment. A new, larger concrete equipment pad will be required. The fenced equipment enclosure may require expansion. The enclosure will require removal of debris and blackberry overgrowth.

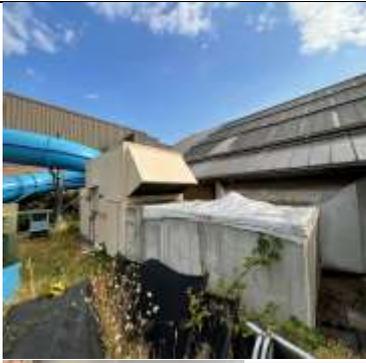
<p>2. Locker Room Heating, Ventilation systems.(Critical - Life safety and energy code)  <u>Deficiency:</u> M002  <u>Recommendation:</u> Remove and replace existing, failed, abandoned heating ventilation equipment installed in the roof penthouses and replace all existing distribution ductwork.</p>

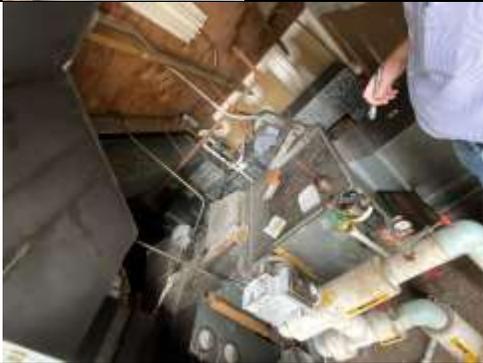
Fire Sprinkler system piping is operable, but the piping is rusty and all fire sprinkler piping needs to be painted. Fire sprinkler piping may require re-configuration in former locker areas.

<p>3. Fire Sprinkler Piping system. (Critical -Life safety)  <u>Deficiency:</u> M003  <u>Recommendation:</u> Clean and re-paint all Fire Sprinkler piping and fittings in all areas of the facility with a rust encapsulating paint.</p>

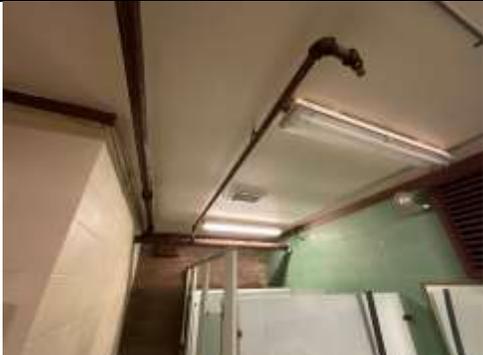
<p>4. Existing rusted Waste and Vent piping. (Secondary-wear and tear)  <u>Deficiency:</u> M004  <u>Recommendation:</u> Existing waste and vent piping is badly rusted from Chlorine fumes. Replace all waste and vent piping with PVC piping.</p>

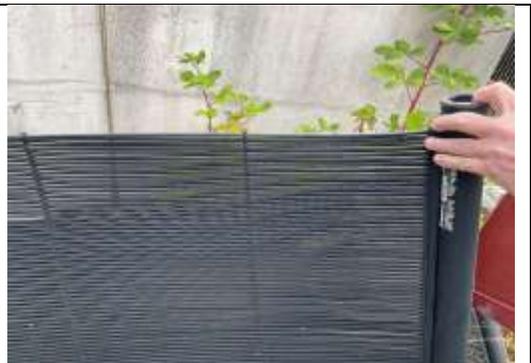
9. Solar Heating System: (Secondary -Wear and Tear)  
Deficiency: M009  
Recommendation: Paint remainder of exposed Roof mounted PVC piping and reconfigure pumps valving for redundant operation.

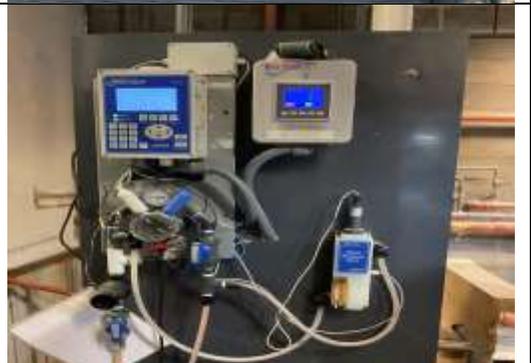
10. Chemical Treatment System (Secondary- Want list)  
Deficiency :M010  
Recommendation: Replace gaseous chemical maintenance system with salt/chlorine system.

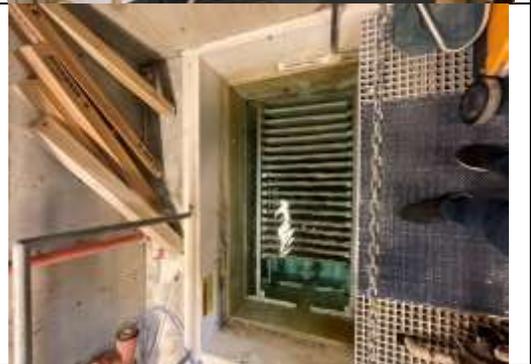
11. Pool Filtration System (Secondary – Want list)  
Deficiency: M011  
Recommendation: Replace existing open DE filter with backwash type sand filter.

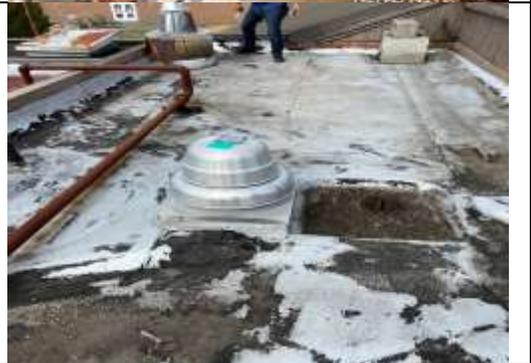
12. Roof Overflow Drains (Secondary – Code Requirement)  
Deficiency: M012  
Recommendation: Install overflow roof drains on locker room roof if roof is replaced.

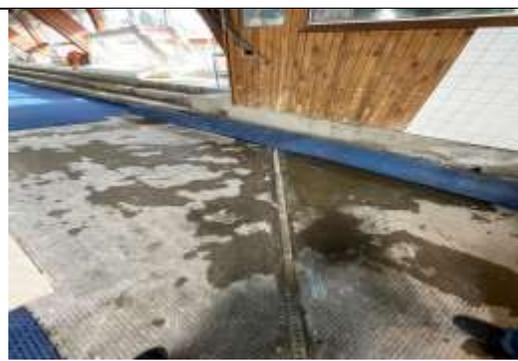
13. Pool Deck Drains (Secondary – system upgrade)

Deficiency: M013

Recommendation: If the pool deck is to be replaced, the deck trench drains should be replaced at that time.

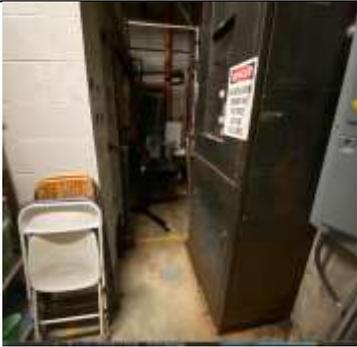
<b><i>Description</i></b>	<b><i>Photo</i></b>
<p>1. Main Distribution Panel (Critical – wear &amp; tear, electrical code, support mechanical upgrades)  <i>Deficiency: Panel is past its life expectancy and is in poor condition with corrosion. Does not meet code-required clearances.</i>  <i>Recommendation: Replace panel with new. Provide code-required clearances. Upgrade electrical service to provide power required for the Pool HV System.</i></p>

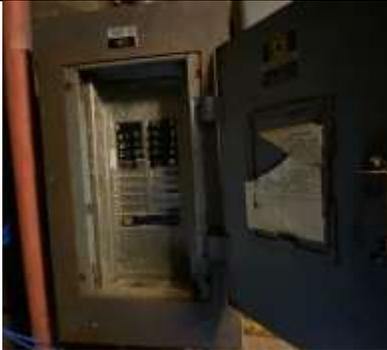
<p>2. Panel X (Secondary – wear &amp; tear)  <i>Deficiency: Panel is past its life expectancy and is in poor condition with corrosion.</i>  <i>Recommendation: Replace panel with new.</i></p>

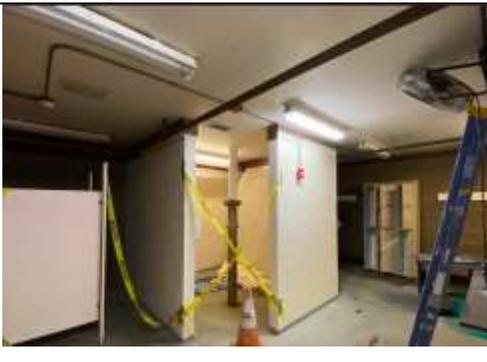
<p>5. Lighting (Secondary – energy efficiency) <i>Deficiency:</i> Lights in spaces other than the pool area utilize fluorescent lamps and are not as energy efficient. <i>Recommendation:</i> Replace all lighting with high-performance LED fixtures that are also properly rated for the environment they are in.</p>

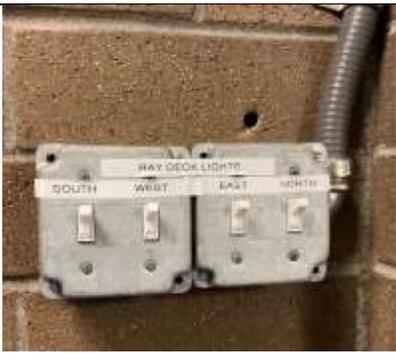
<p>6. Lighting Controls (Secondary – energy code and improved user experience with dimming) <i>Deficiency:</i> Lights in offices, lockers, and storage areas are controlled via line voltage switching with no occupancy sensor control. <i>Recommendation:</i> Replace with digital or wireless lighting control and provide occupancy sensors for automatic shutoff.</p>

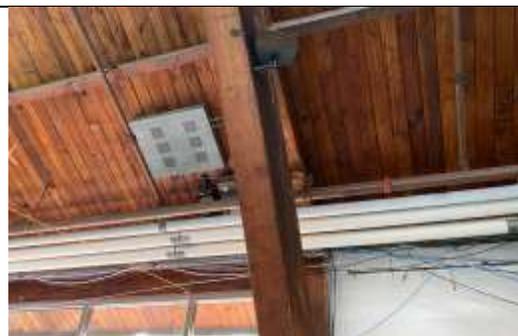
7. Communication Cabling Support (Secondary – low voltage cabling standards)

*Deficiency: Low voltage communication cables are not installed in a neat and workmanlike manner, with some cables supported by extremely rusted piping.*

*Recommendation: Neatly bundle cabling and route in its own raceway or cable tray where exposed.*
